The Impact of Using a Used Total Knee Replacement Set on Clinical Outcome

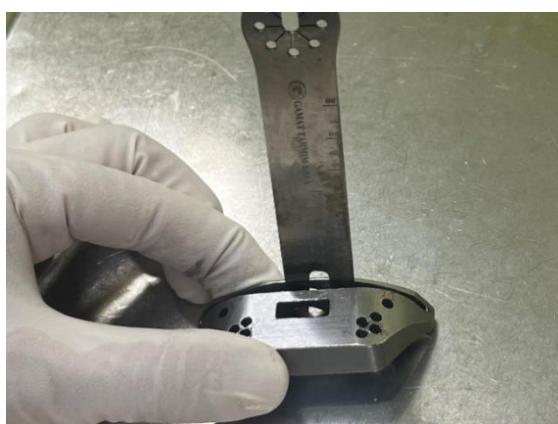
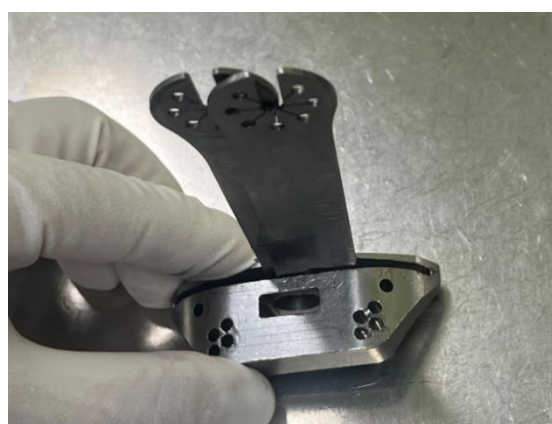
Figure 1: The widths of cutting slot in old set is twice as new one.

while in the new set group, it was 2.5 (0-6). In terms of comparing instrument deformity, we did not find significant visual differences between the two sets. However, the width of the jig cutting guides for the distal femur and proximal tibia was markedly different, with corrosive wear in the old set causing a widening of 4 millimeters in the femur jig and 3 millimeters in the tibia jig (Figure 1). This widening allows pendulum movement of the orthopedic saw blade and could result in the removal of more bone than intended.

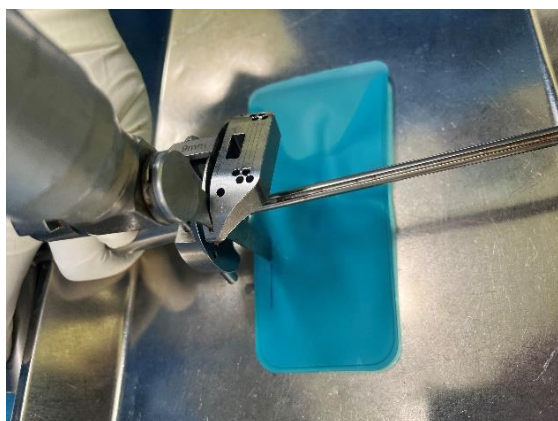
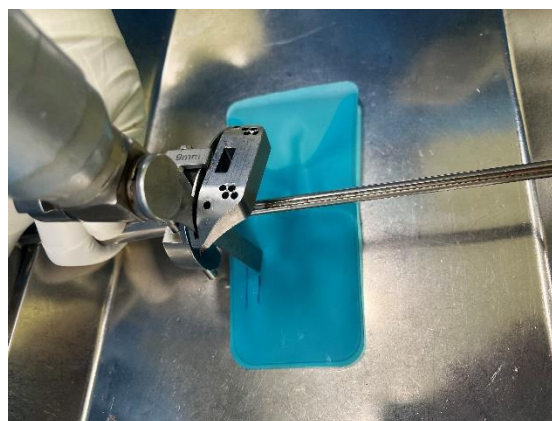
Figure 2: Due to wider slot in old case more bone is resected using old set

Attention to the potential for corrosive wear is essential not only to maintain accuracy in surgical techniques but also to minimize the risk of failure in knee joint replacements⁽⁸⁾. Bone cutting jigs primarily have grooves where the orthopedic saw blade enters and performs the bone cutting along these grooves. The diameter of these grooves corresponds to the diameter of the saw blade to prevent pendulum movement and ensure precise cuts strictly along the jig grooves. Over time, continuous use of the saw blade and the development of corrosive wear increase the diameter of these grooves, allowing pendulum movement of the saw blade, resulting in greater bone removal (Figure 2).
